NASA Contractor Report 165635

Advanced Composite Aileron for L-1011 Transport Aircraft Design and Analysis

C.F. Griffin and L.D. Fogg

Lockheed Corporation
Lockheed-California Company
Post Office Box 551
Burbank, California 91520

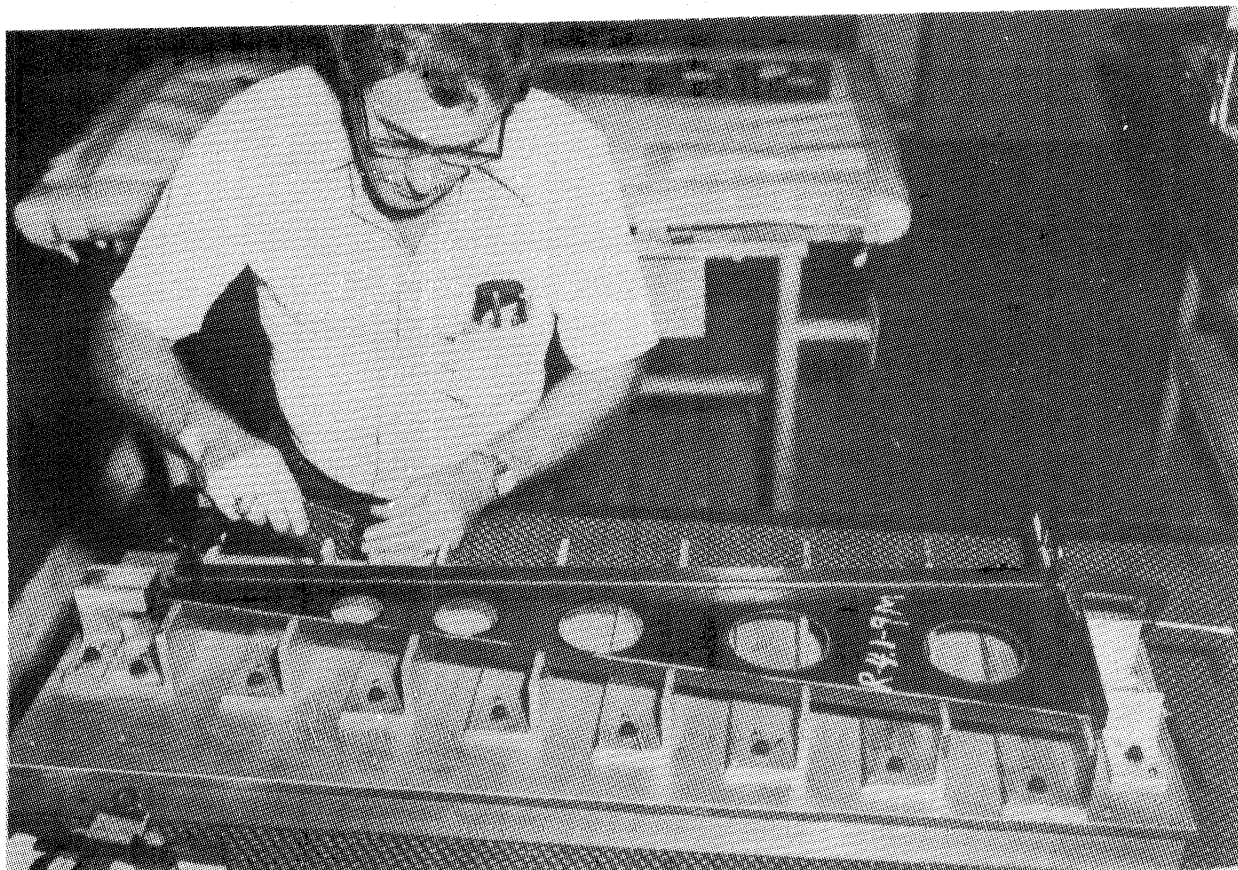
Figure 56. - Rib dimensional check fixture.
